**THE STATUS OF LANDSLIDE OCCURENCE IN WEST POKOT:  
THE IMPACT OF SOIL AND WATER CONSERVATION INTERVENTION  
OVER THE LONG RAINY SEASON**

Prof. Wilson Ngétich

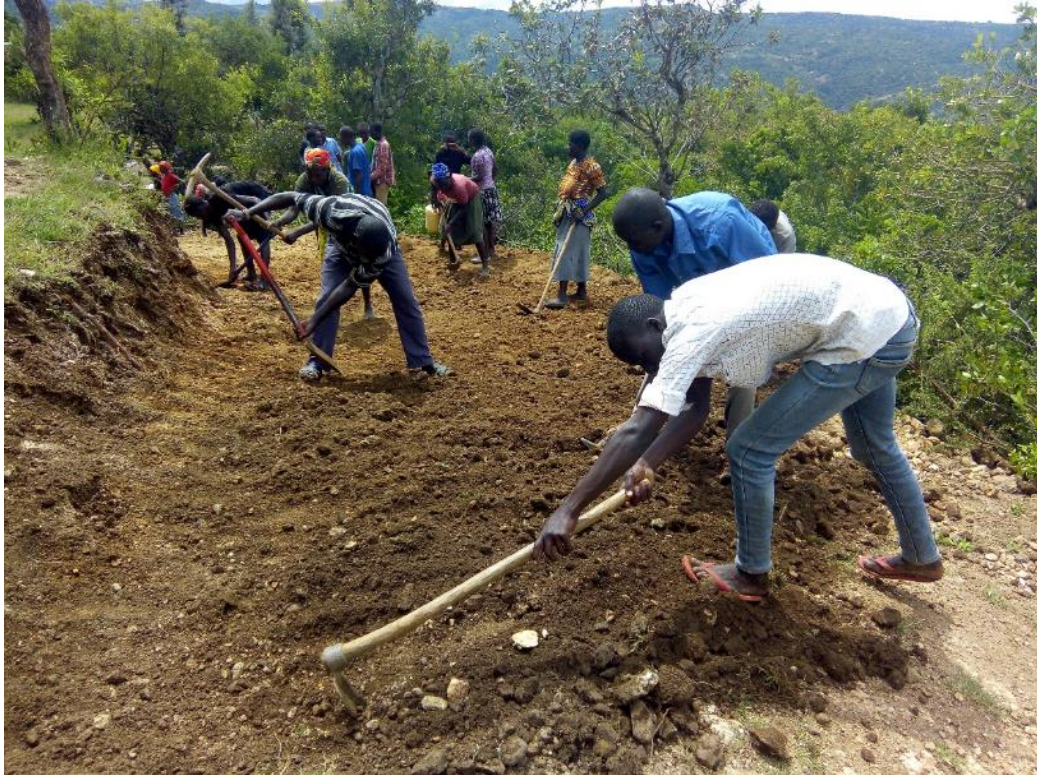
**Figure 3. Combined efforts by drylands FRN farmers and the community in opening up new roads in Kaporowo. (Photograph courtesy of Mr. Richard Kitony, the secretary Kapkitony farmer group, taken in January 2020)**

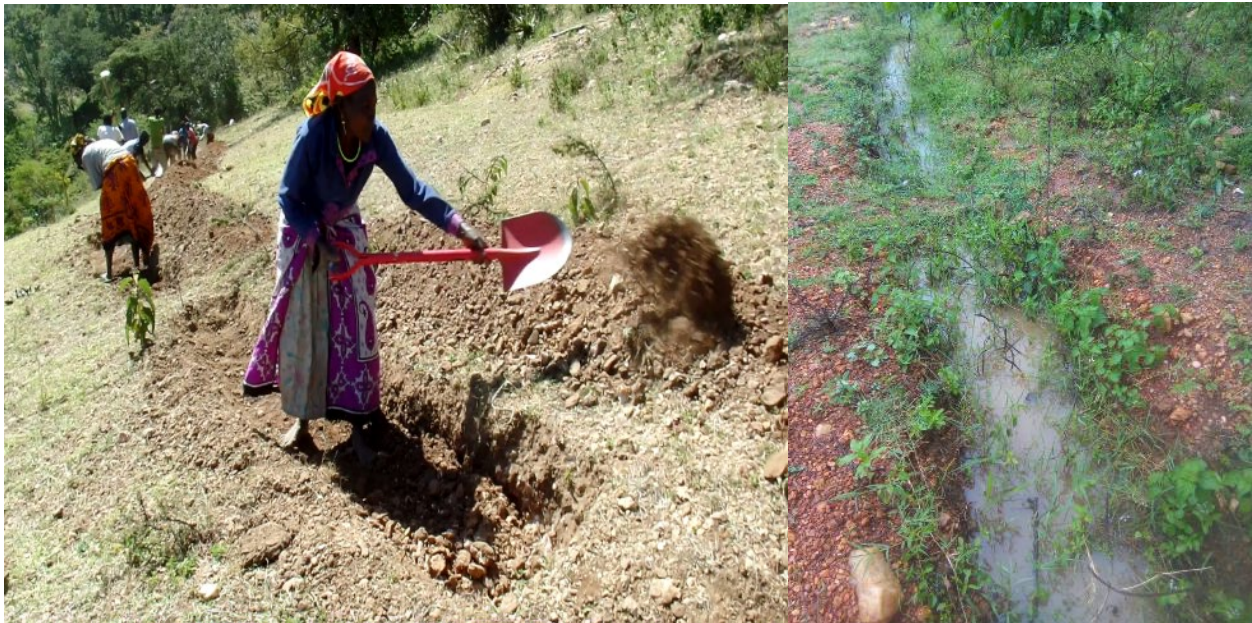
**Figure 4. (a) Farmers constructing terracing in Kaporowo in 2019 and (b) the view in April 2020 on the benefits of terracing in reducing water speed, retention and increasing the time and amount of water infiltrated. (Photograph taken by Mr. Alkamoi Bonface, University of Eldoret)**

**a. Terraces**

- Seeds planted by farmers are no longer swept by water surface run-offs like before
- Improved crop growth in the farms allowing production of crops into the second season which was not possible before
- A notable reduction in the speed of water surface run-off flowing at the farm level
- Improved water retention in the farms
- Reduced gully growth on the head and width (perceived healing of gullies?)
- Increased vegetation and grass production / growth in the farms where terracing had been done

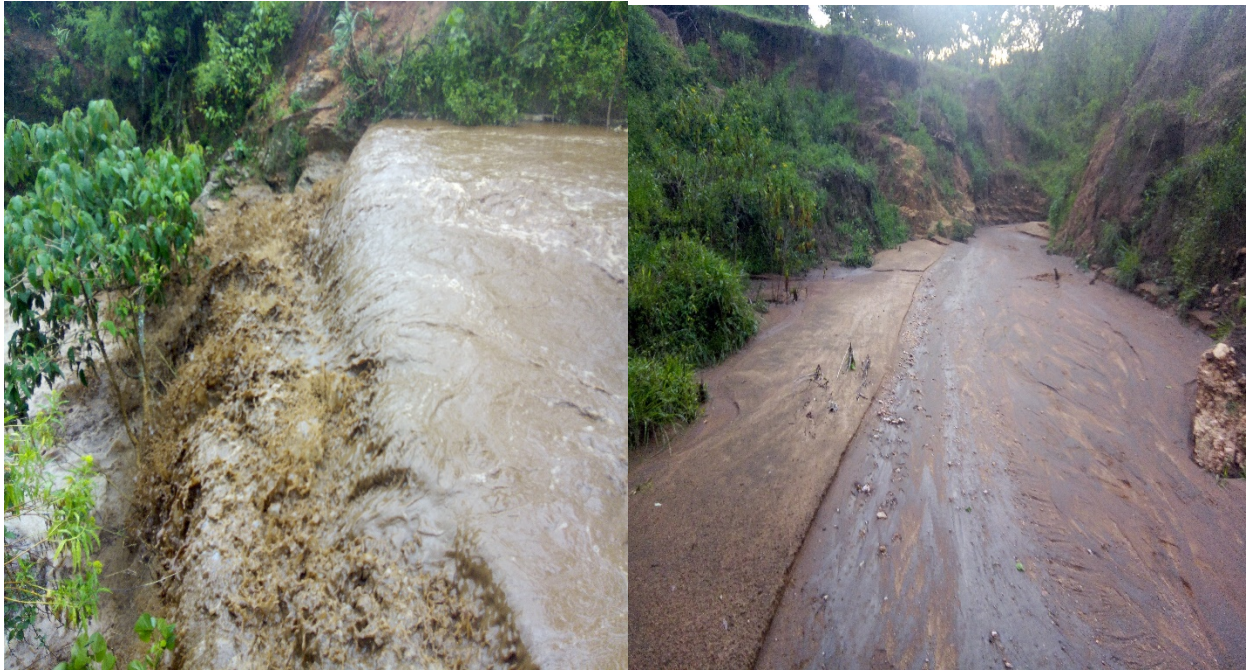
***Figure 5. Sand dam providing physical barrier to water movement along the gully channel thereby (a) considerably reducing the speed of flash floods and (b) retaining sand.***

**b. Sand dams**

- Decreased speed of flooding water in the gully channels
- Increase accumulation of sand up-hill
- Development of new streams and regeneration of streams in areas where they had ceased flowing thus providing clean potable water for domestic and livestock use
- Increased growth of grasses and other vegetation along the gully's with sand dams
- Reduced gully growth

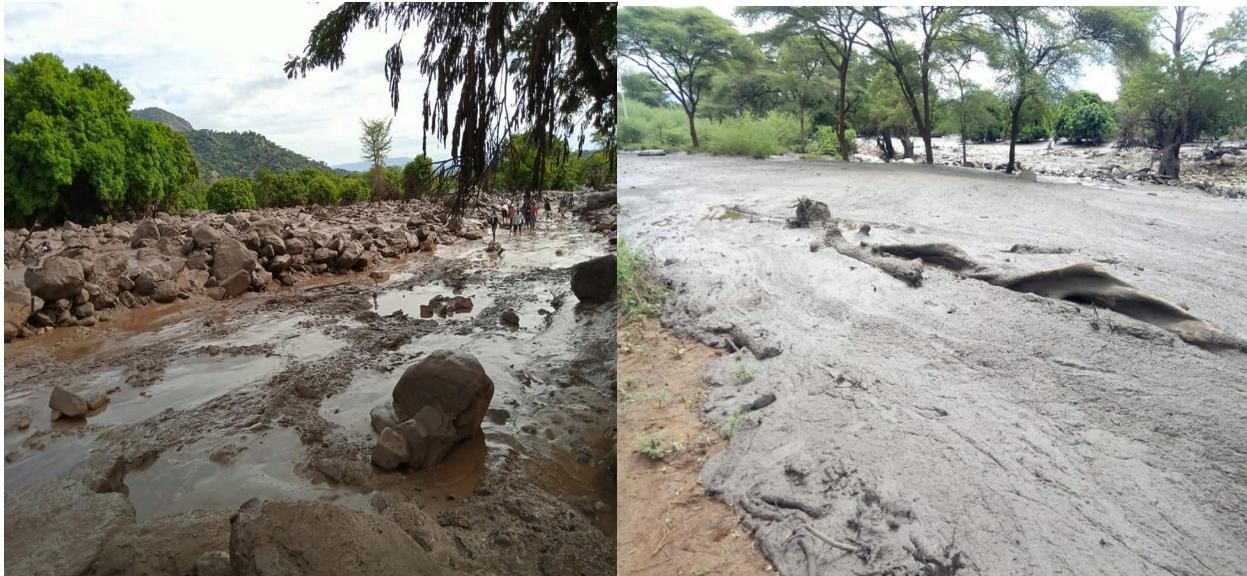
***Figure 6. Landslide in Elgeyo Marakwet and West Pokot Counties that resulted to a mass flow of rocks and mud downhill along in Chesogon. Photograph taken by H.E Governor John Lonyangapuo on 19<sup>th</sup> April 2020.***

The most recent landslide occurred on the border of West Pokot and Elgeyo Marakwet, in April of 2020, because of heavy downpour in this high-altitude area. It occurred in the afternoon, giving the residents time to evacuate following distress calls to do so from those who witnessed the mass movement from higher ground (implying that it would have been worse had it occurred in the night). The devastating effects were felt downhill in the Liter and Chesogon areas where the flash floods and mudslides carried along anything its path, including people, livestock, houses, schools, a police station, the post office, and many homes. A total of 4,000 people were displaced, many were injured and about 29 lost their lives in the tragedy. The heavy rains cut-off the bridges at Marich and Chepera along the Makutano – Lodwar highway affecting public transport and delivery of essential goods and services as well as medical supplies.
